IMPORTANT SAFETY NOTICE -- ACTION REQUIRED 1/1/2017

For POOL LIFT Models IGAT-180, -135, -90 (not HD or AD models)

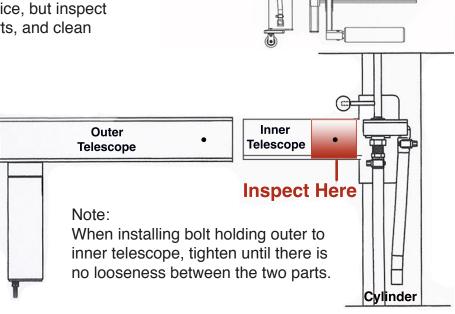
We recently had reports of corrosion resulting in breakage of an out-of-warranty structural element-the inner telescoping component near where it is welded to the cylinder. Without proper maintenance, corrosion formed over many years on the inside and outside of the inner telescope. The corrosion weakened the stainless steel, cracks developed, and the piece failed slowly enough so that no one was hurt. Highly chlorinated and true saltwater pools will have more corrosion on stainless steel surfaces and require regular inspection and maintenance. Based upon reports, heavily used lifts in indoor pools with high chemical concentrations in the air are most at risk. These reports currently **represent 0.04% of the lifts in service, but as the possibility of injury does exist**,

Remove footrest and seat assembly to lessen weight for handling. With P-Frame in lowered position, remove cylinder from socket/water and lay on deck.

Remove bolt holding together the inner and outer telescoping parts of the mounting arm. Slide outer arm off.

Inspect inside and outside both pieces for corrosion, rust, pits, cracks, and thinning of the metal. A stainless steel wire brush will help remove any rust. Use a rust remover and thoroughly clean any residue and rinse well. Inspect again.

If there is any doubt, remove the lift from service. Send photos of affected parts to Safety@AquaticAccess.com.

If the pieces are sound, continue service, but inspect periodically for corrosion on these parts, and clean and polish as needed.
